BROWN SHANTY LAKE DAM

GASCONADE COUNTY, MISSOURI

MO 30187

PHASE 1 INSPECTION REPORT NATIONAL DAM SAFETY PROGRAM

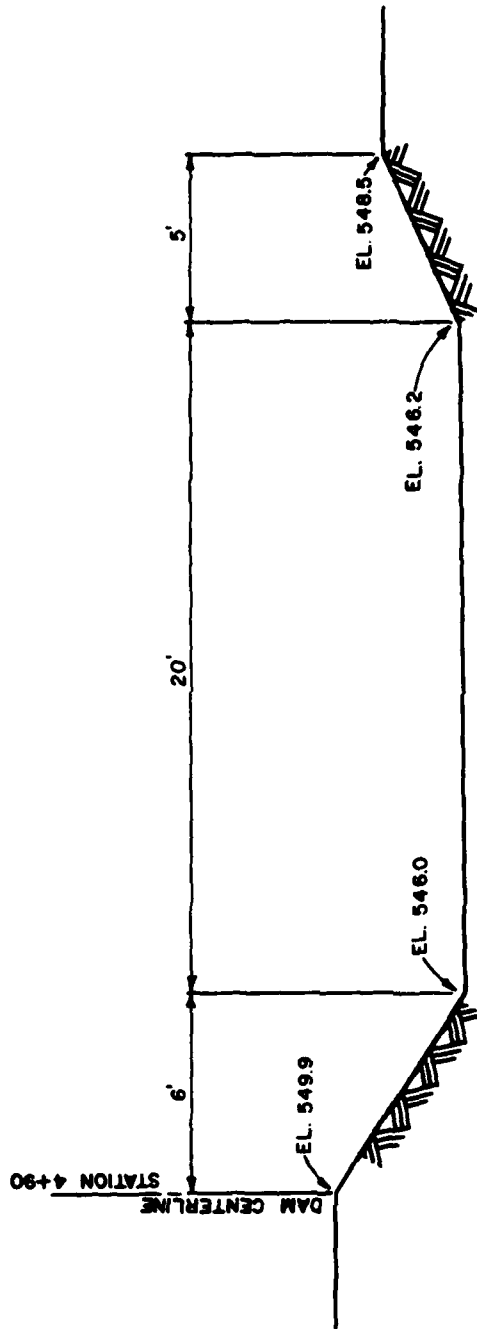
BROWN SHANTY LAKE DAM PRIMARY SPILLWAY CROSS SECTION

NOTE:
CROSS SECTION TAKEN
NEAR DAM CENTERLINE
STATION 4+90 LOOKING
UPSTREAM
